Fitesa Surpasses Washington Department of Ecology Stormwater Quality Standards

By Linda Barney, Barney and Associates

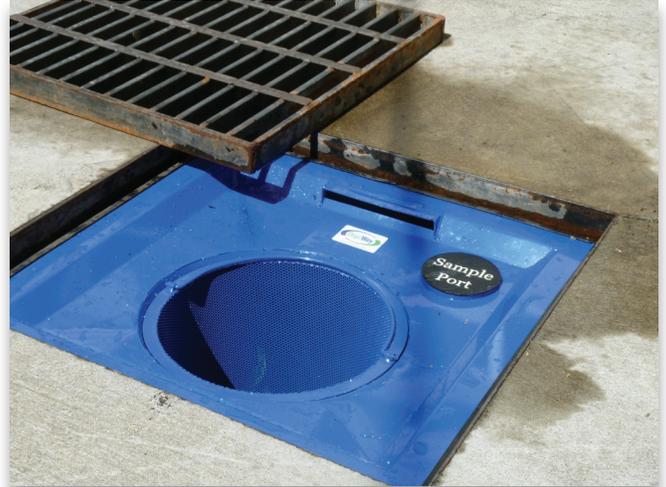
There were seven manholes on the south side of the Fitesa building and in the shipping truck bays. CleanWay installed a Catch Basin filtration system containing a sediment pre-filter and metals main filter in each of the manholes. The Fitesa filtration system stops trash and debris, sediment and TSS, oil and hydrocarbons, and dissolved metals at the source. Fitesa staff usually change the pre-filter once a month and the main metals filter once every 3 months (site conditions and weather determine how often filters need to be changed.) There were some initial problems with alignment of the filters but Fitesa and CleanWay staff resolved the issue quickly. Hisey reports that they also added a CleanWay downspout filter for water coming off the roof and re-routed stormwater off a side building so that it went into a manhole containing a CleanWay filter.

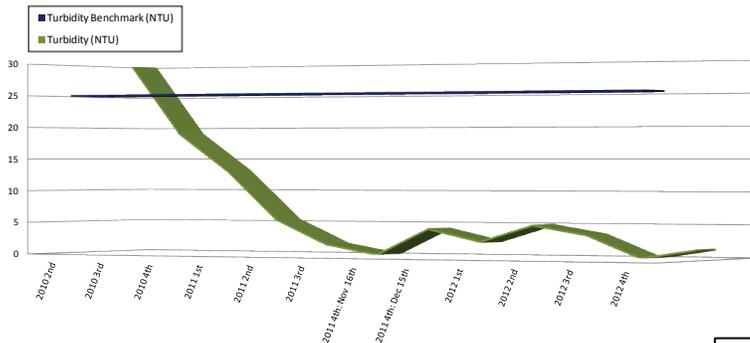
Fitesa Turbidity Sample Data with CleanWay Filters

“Since implementing CleanWay solutions, the stormwater discharge levels for zinc and copper are within or below accepted standards.” The accepted zinc discharge standard is 117 µg/Liter and Fitesa’s 2012 discharge levels for zinc were 114, 106 and 87 µg/Liter. The copper levels are below accepted levels of 14 µg/Liter; 2012 copper discharge readings were 4, 2 and non-detectable. In addition, turbidity readings have also been reduced.

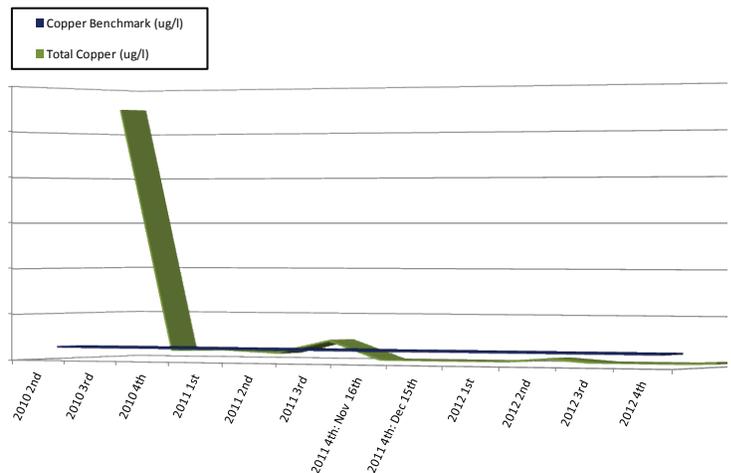
Fitesa Copper Sample Data with CleanWay Filters

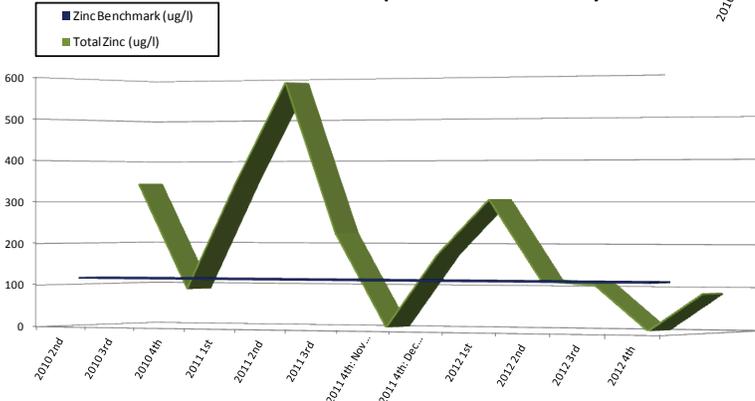
Fitesa Zinc Sample Data with CleanWay Filters
